Daily Report For 2016-05-18

Metal Bank

Sheetpile Repair
Cottman Avenue
Philadelphia, PA (US)
Report number: 3340011G-9
Date: May 18, 2016 01:21 PM

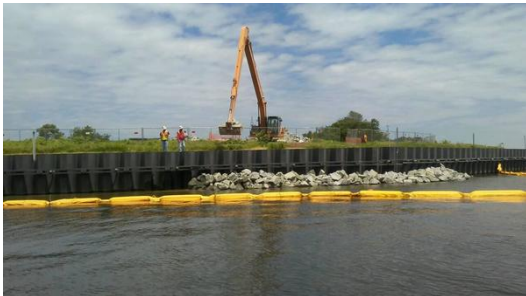
Remark	Description	Assignee(s):
Rip-Rap		
✓ <u>R6 stone placement</u> <u>[3.1]</u> May 18, 2016	(see pics below)

View of stone berm construction progress in Zone 2 (facing North).
